**Commonwealth of Massachusetts**  
**Department of Public Safety**  
**INCIDENT REPORT**

*Dominion Energy New England - Salem Harbor Station*  
*Salem, MA*  
*Boiler #3 Failure - November 6, 2007*

**Graphic representation of failure area**

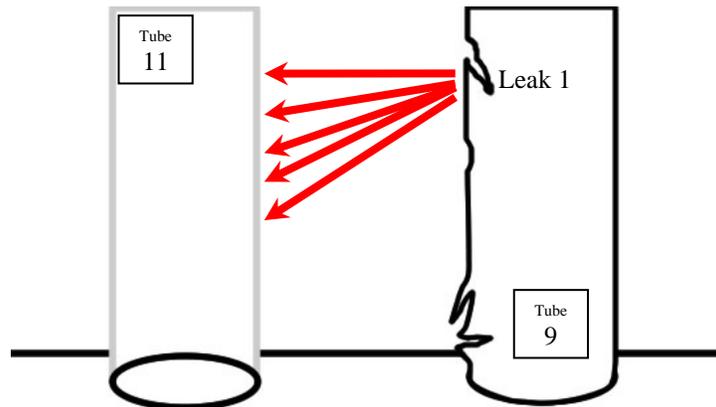
1. Tube 9 begins to leak as a result of a significant welding flaw at the time of manufacture, and external corrosion

a. Leak strikes Tube 10 and 11 causing “collateral damage”

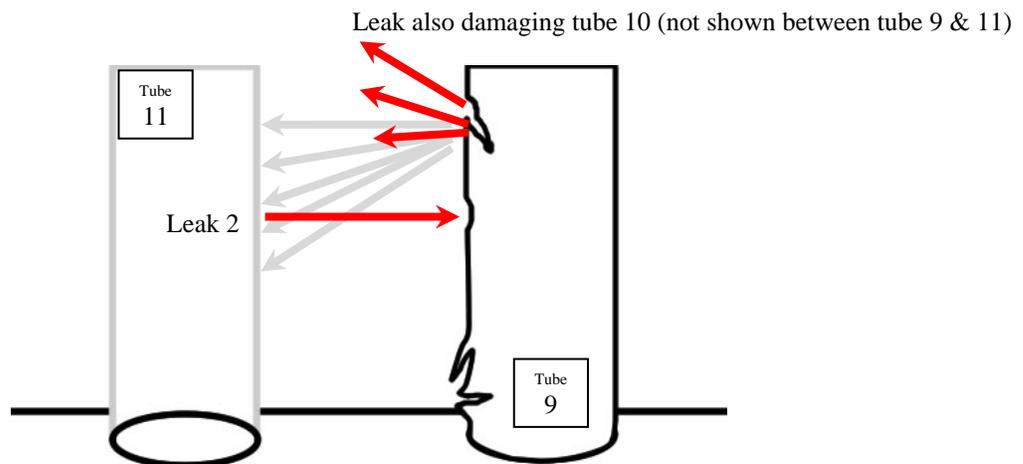
2. Initial leak in Tube 9 continues to damage Tube 10 and 11

a. Tube 11 begins to leak and starts to damage Tube 9

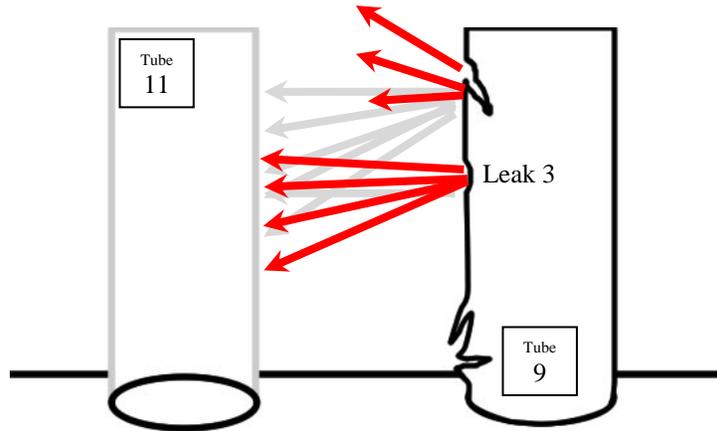
3. All leaks continue to progress.
  - a. Leak from Tube 11 results in a new leak in Tube 9, continues to damage Tube 10

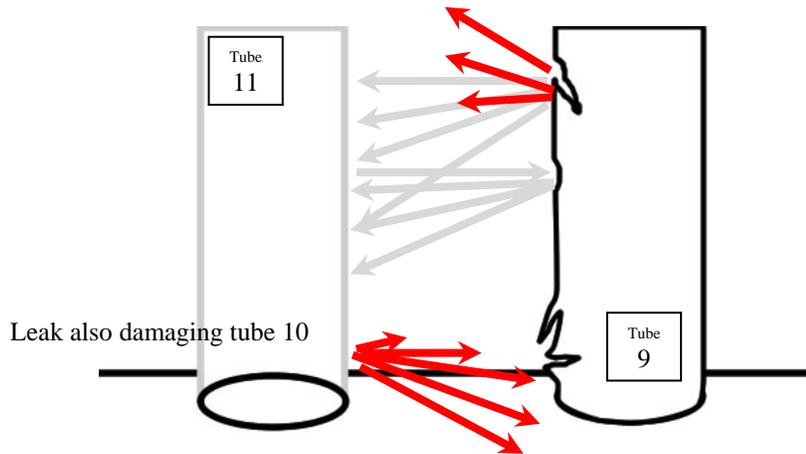
4. All leaks continue to progress and worsen
  - a. New leaks from collateral impingement damage develop

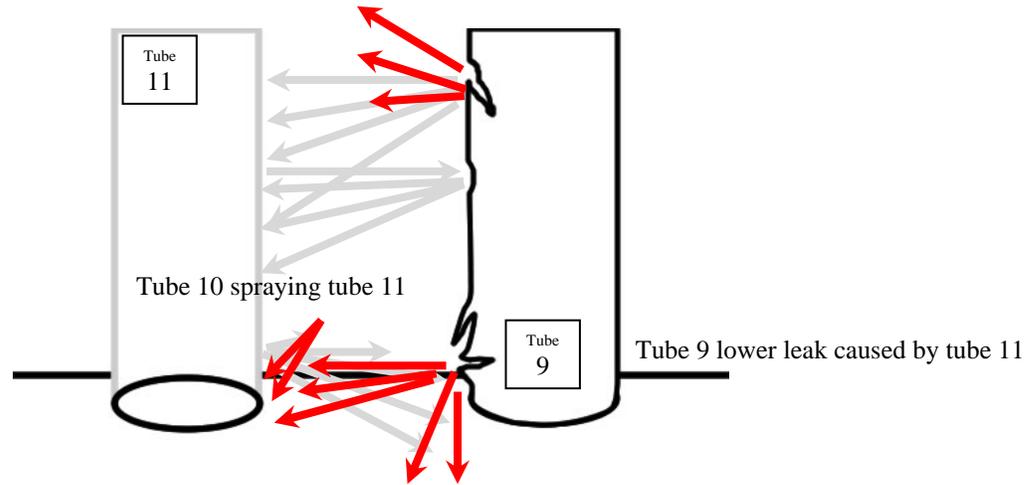
5. All leaks continue to progressively worsen over time
  - a. Tube 10 is thinned along one plane far below minimum wall thickness
  - b. Tube 11 is also thinned considerably below minimum wall thickness
  - c. Tube 10 fails catastrophically forcing steam/hot water in the direction of Tube 11
  - d. The lateral force applied by the failure of Tube 10 toward the weakened Tube 11 causes Tube 11 to separate from the header.

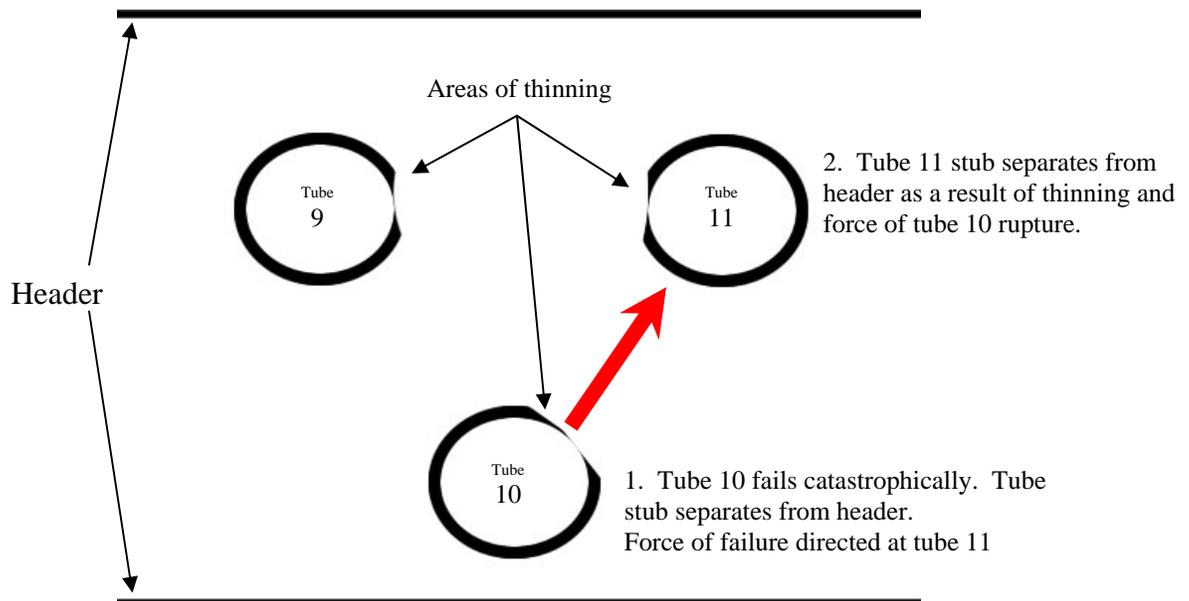
6. View of tube arrangement on header looking down.
  - a. As stated in (5) above, the lateral force applied by the failure of Tube 10 toward Tube 11 caused the already weakened Tube 11 to separate from the header.

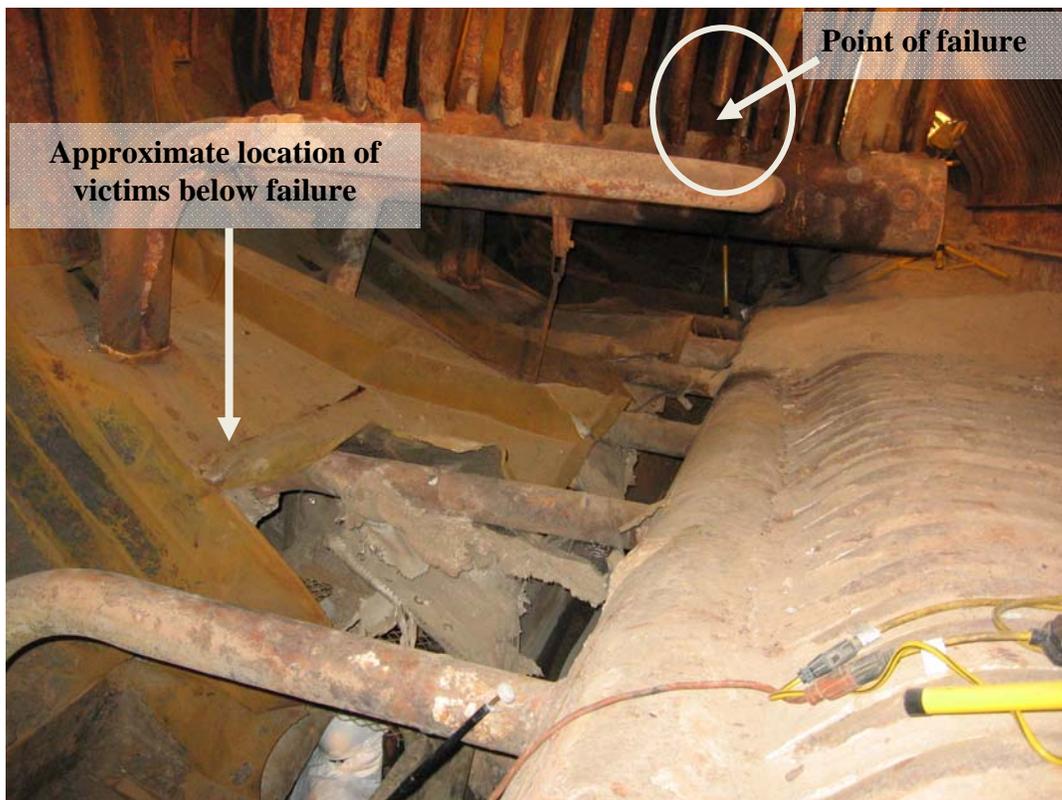
4. Dead air space showing ruptured boiler casing (facing south)

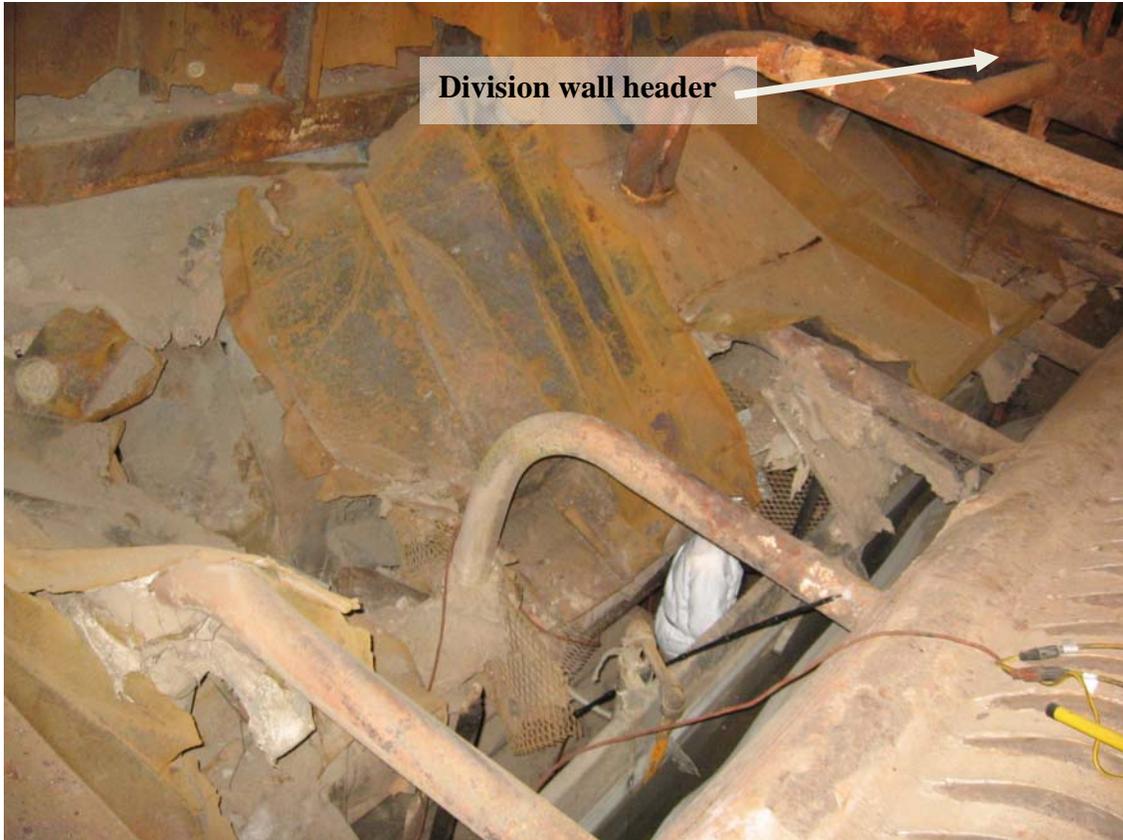
**5. Dead air space showing ruptured boiler casing (looking down, facing south)**

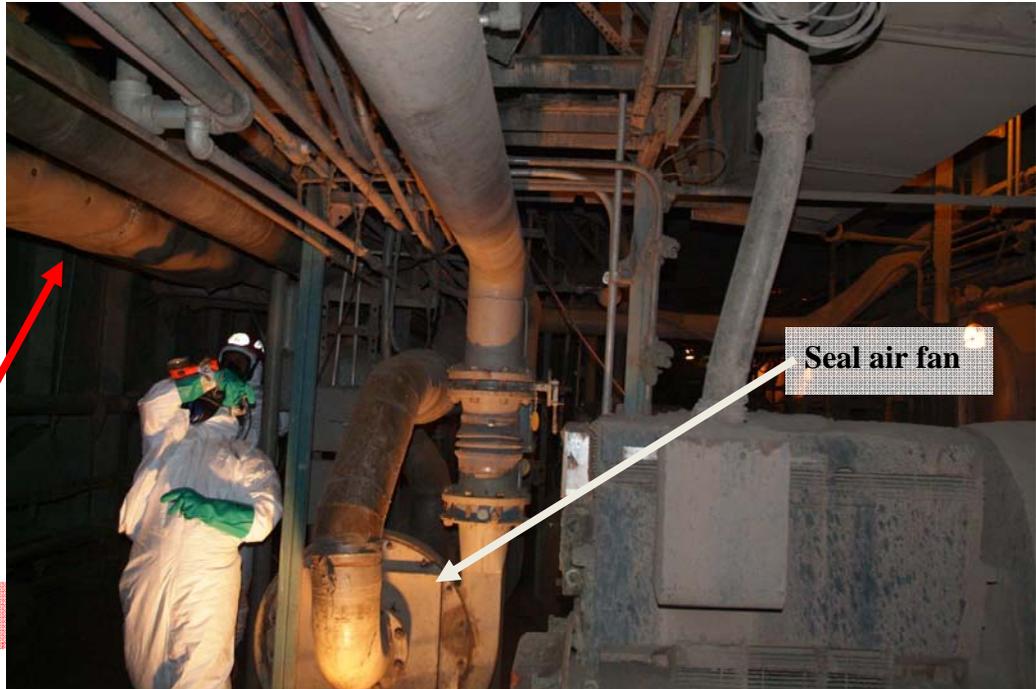
Point of casing rupture

7. Area adjacent to point area below failure (facing south)

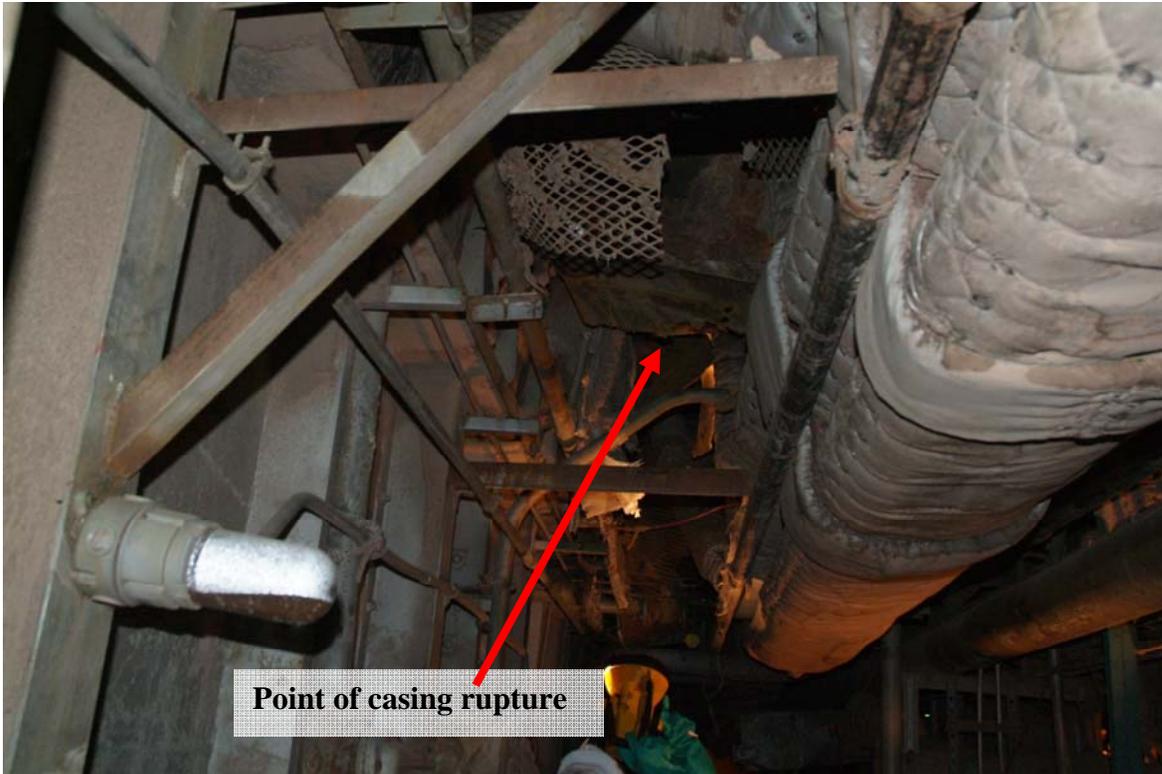
Point of casing rupture

8. Area immediately below casing failure (facing south)

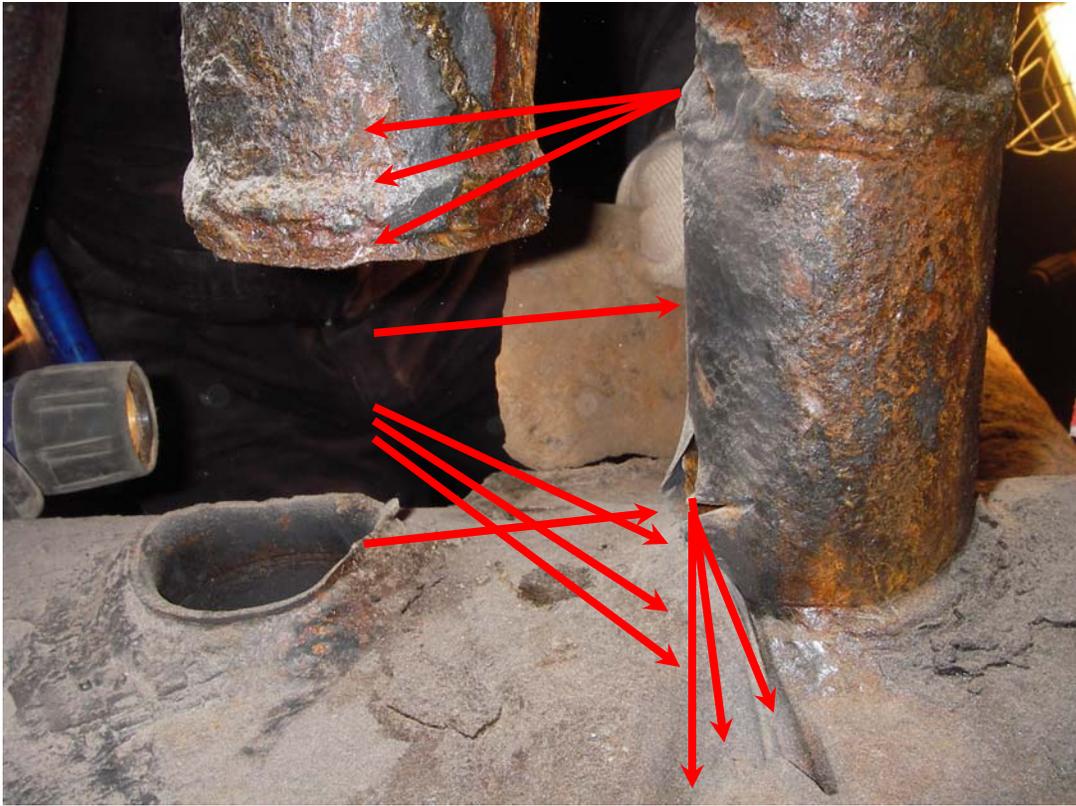
**15. Steam impingement indications between tube 9 and 11**

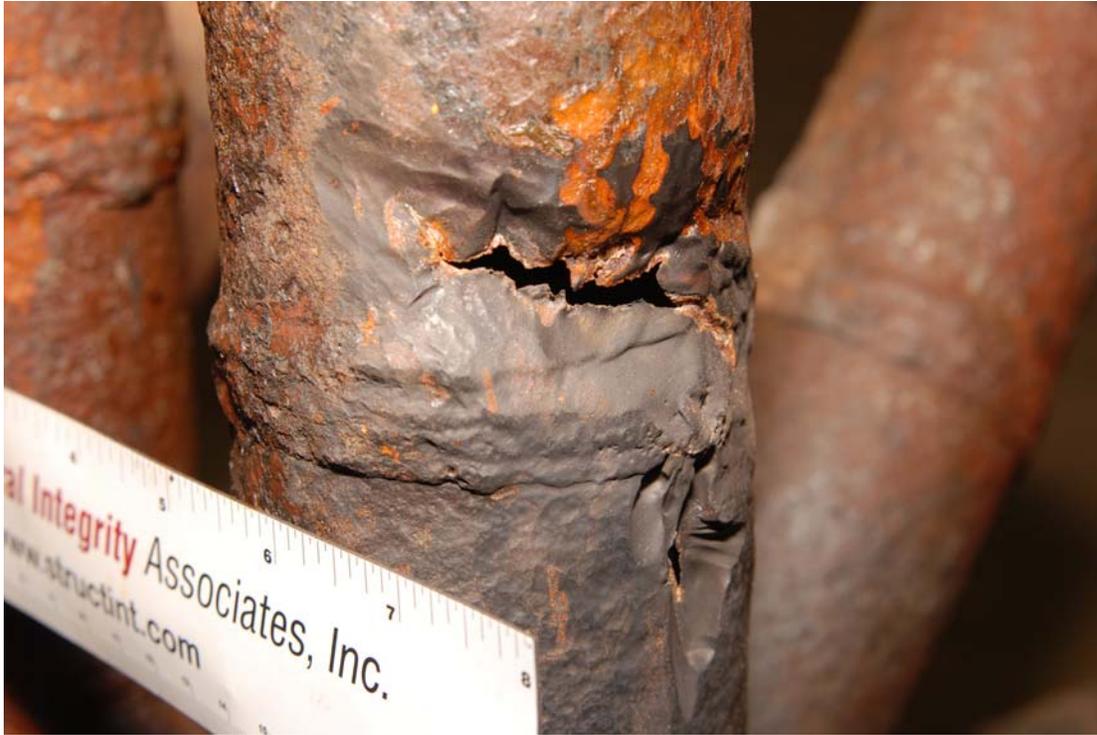
**21. Close-up of tube 9 top leak**

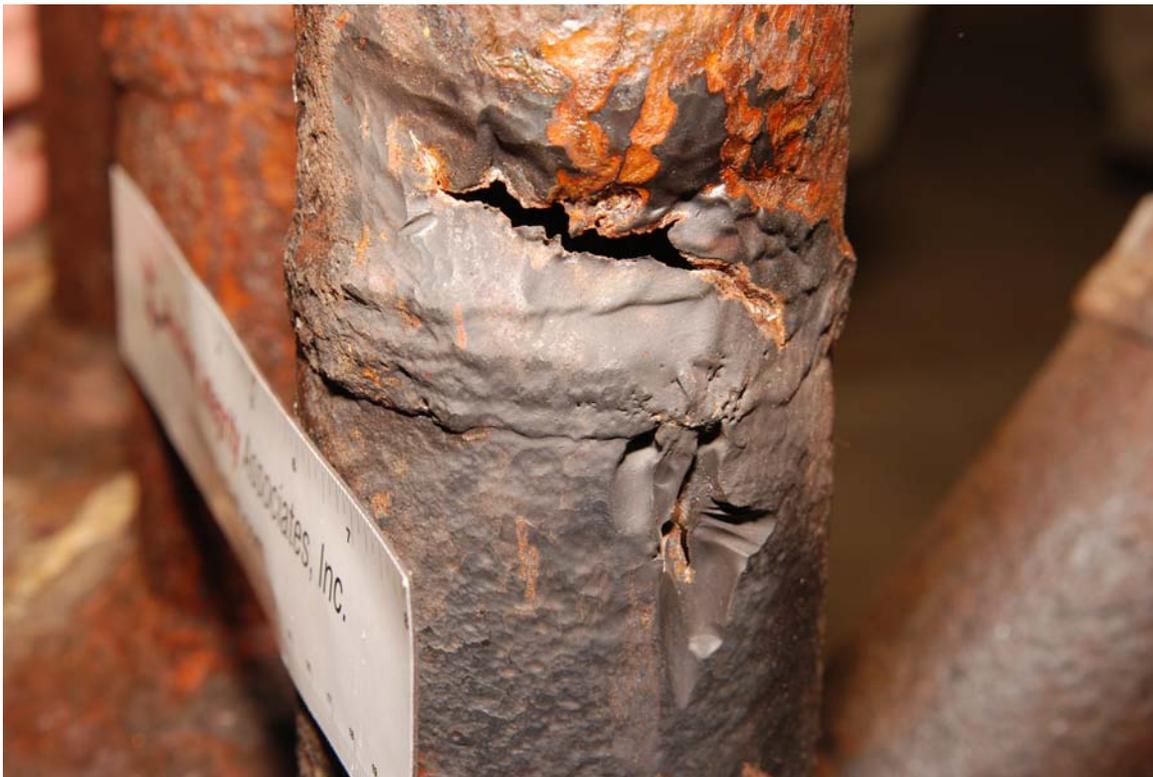
**22. Close-up of tube 9 top leaks**

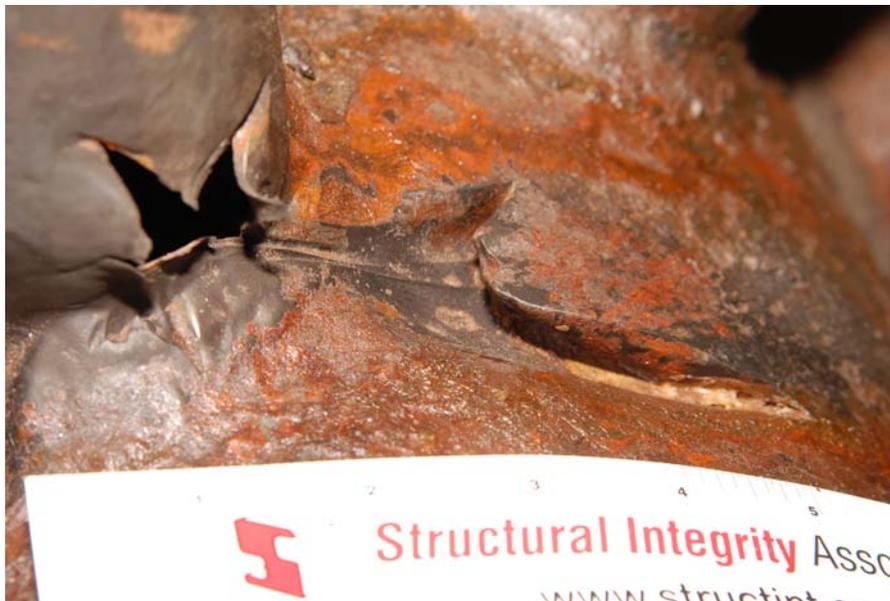
**29. Close-up of header damage from steam/water impingement**

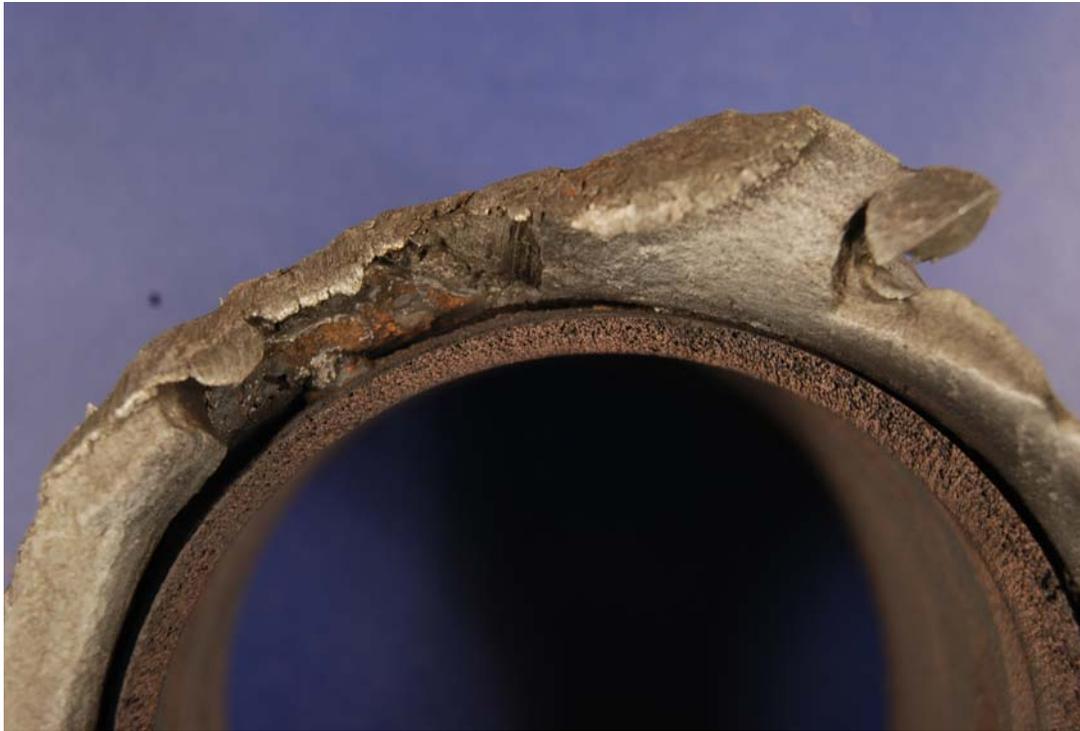
**30. Close-up of Tube 10 showing poor weld**

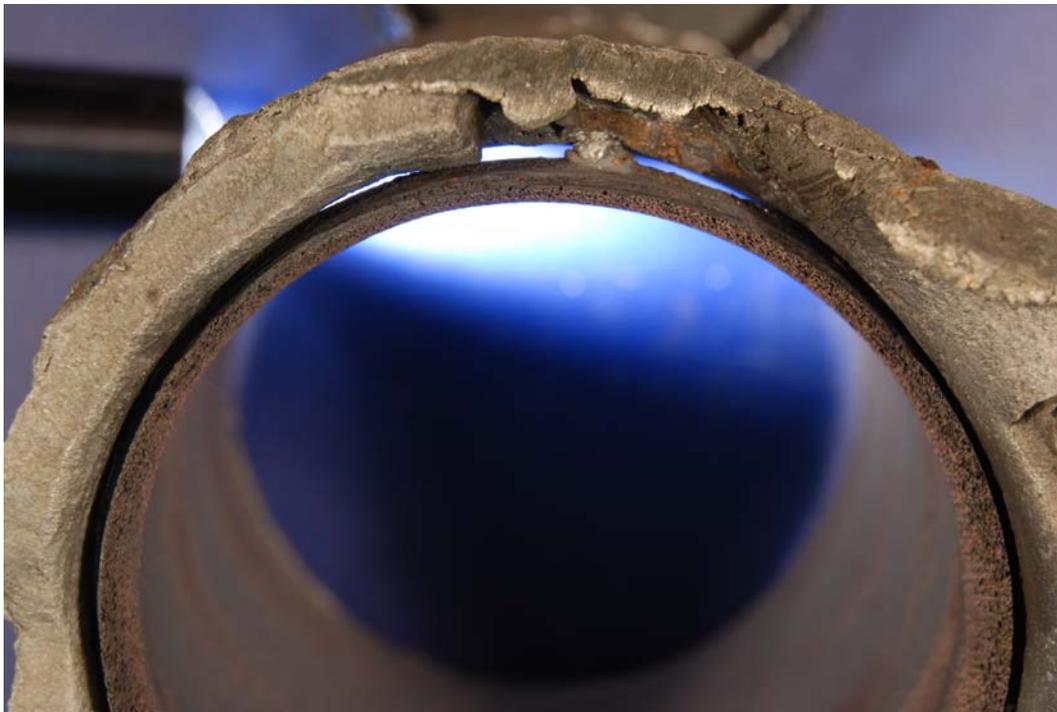
**31. Close-up of Tube 10 showing poor weld**

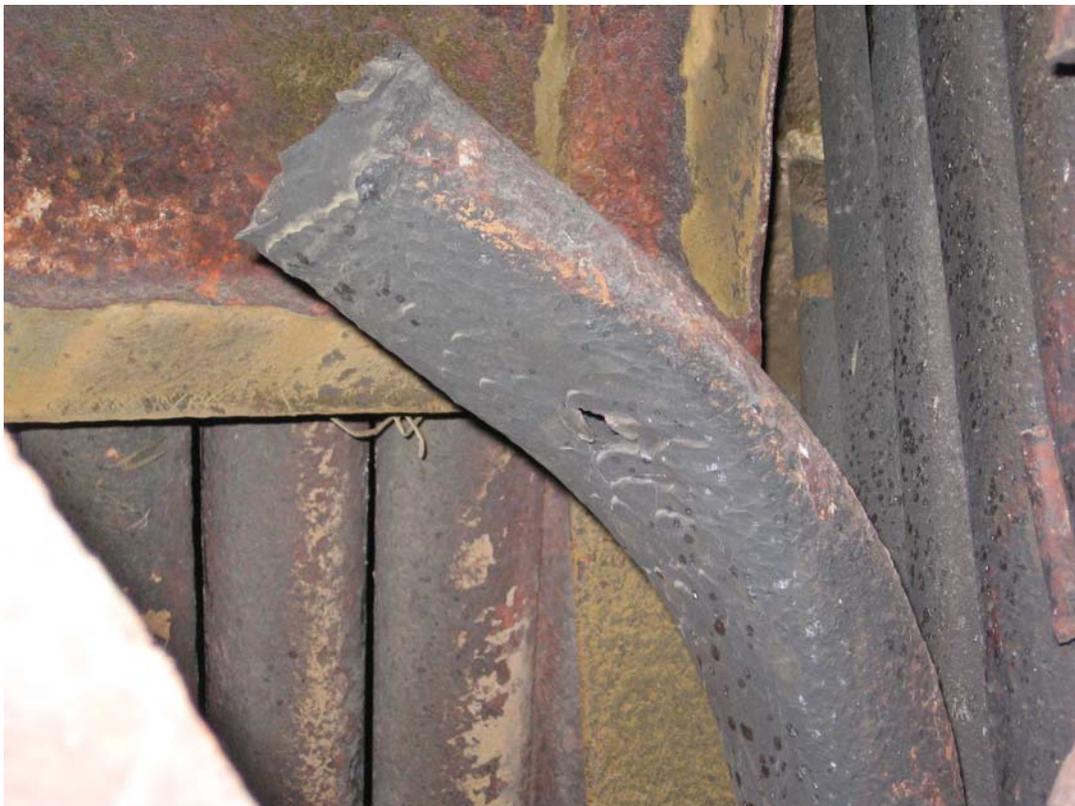
**33. Tube 10 showing damage from steam / water impingement**

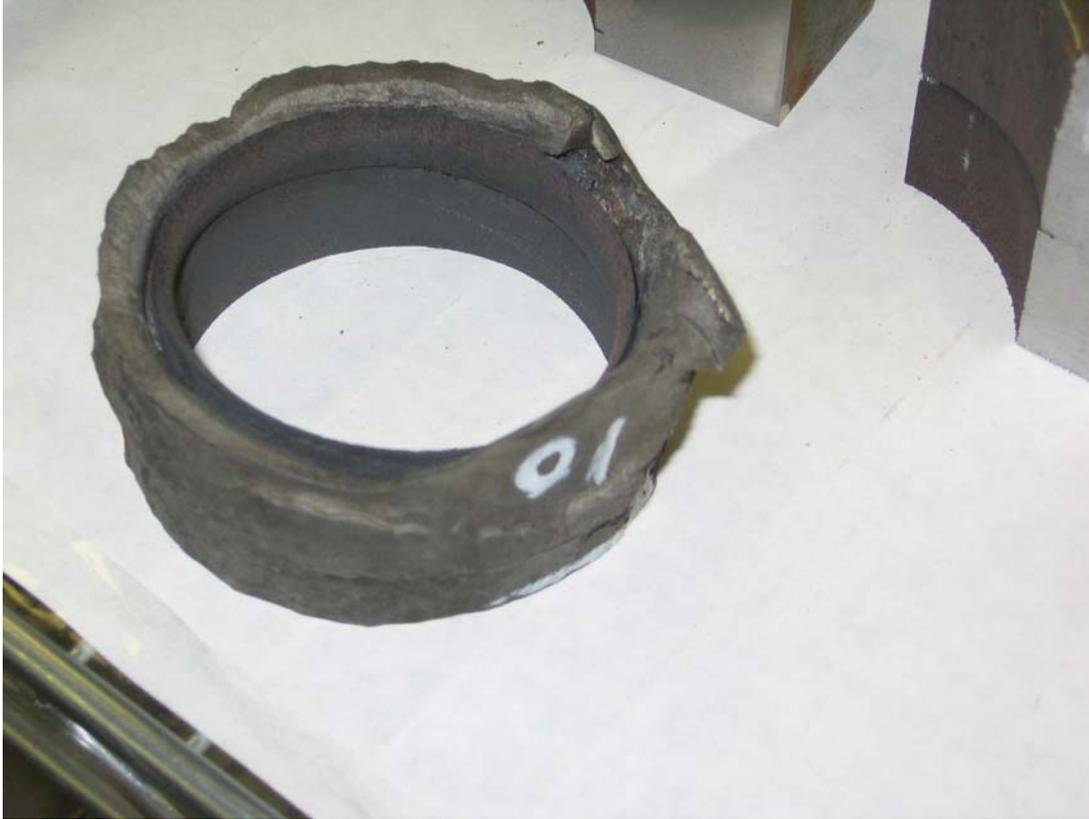
**38. Cut away of Tube 10 stub (with bad weld)**

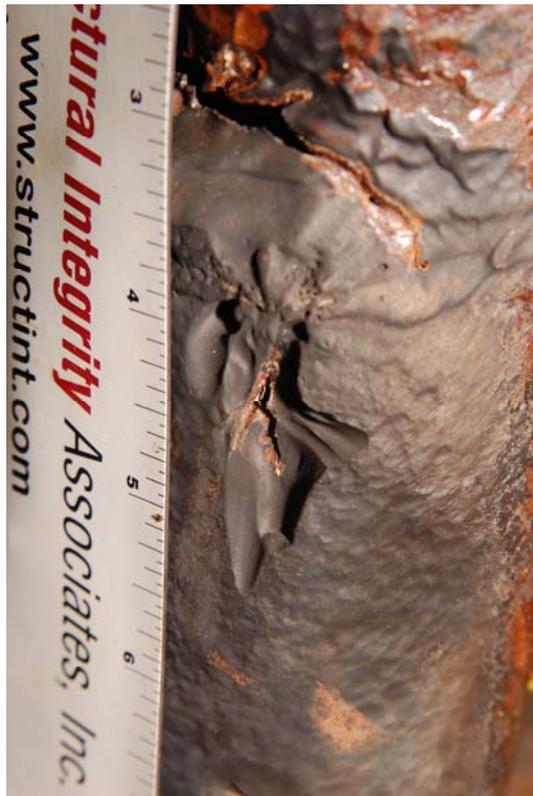
**41. Close-up of Tube 9 middle leak**

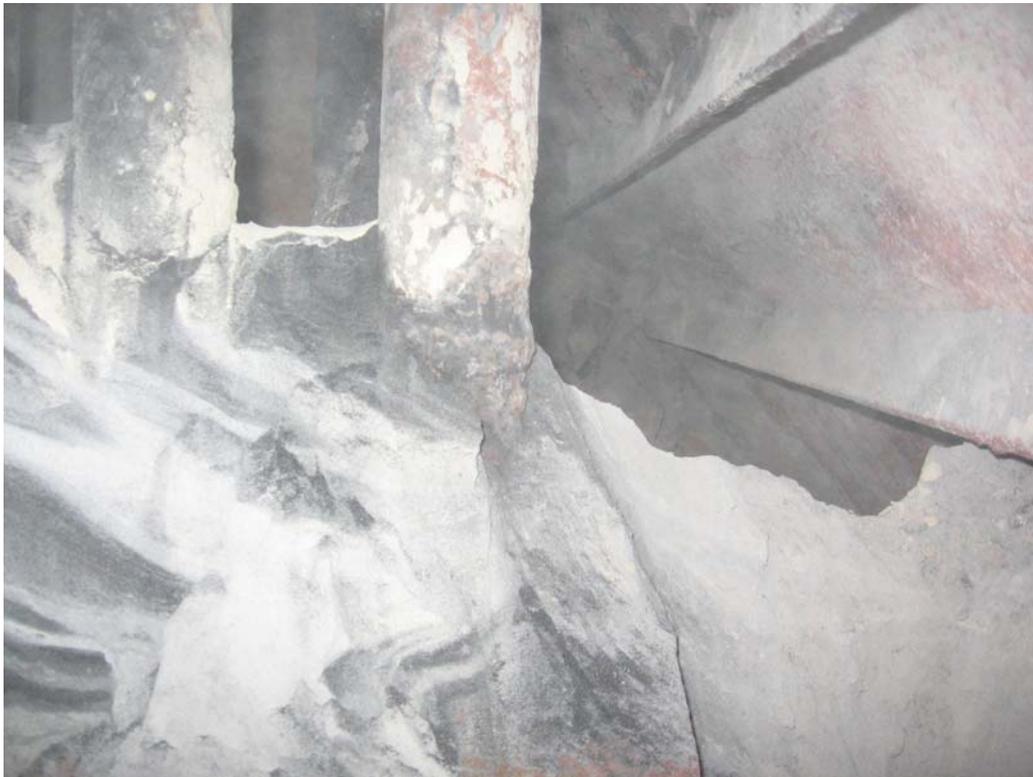
Based on (1) the volume of ash that emptied into the area below the failure, (2) the volume of ash in the west side dead air space, (3) the level of corrosion on the tubes and header in the lower dead air space, and (4) the number of witnesses that confirmed the existence of ash in the lower dead air space, we determined that the lower dead air space was full of ash prior to the failure. To determine the volume of ash that was in the east dead air space in relation to the space, the DPS gained access to the dead air space opposite the space the failure occurred in. This space was virtually a mirror image of the area in which the failure occurred and was under the same operating conditions. This space (west side dead air space) could not be entered because of the heavily packed ash filling the space and blocking the entrance. The DPS ordered a channel in the ash, within the west side dead air space, be dug to gain a better view the current conditions of the space. The ash in the space was a mixture of fine ash and hardened solid rocklike form. The solid ash was broken up with poke rods and shovels and vacuumed out of the space. Mooney observed the space to be nearly full of ash, with the west side division wall header (directly opposite the one that was involved with the failure) completely encased in ash. The header and tubes on the west side had similar corrosion to that found on the east side. (See photos 42 – 53).

**43. West side dead air space before ash is completely removed  
Tubes encased in ash going to lower header**

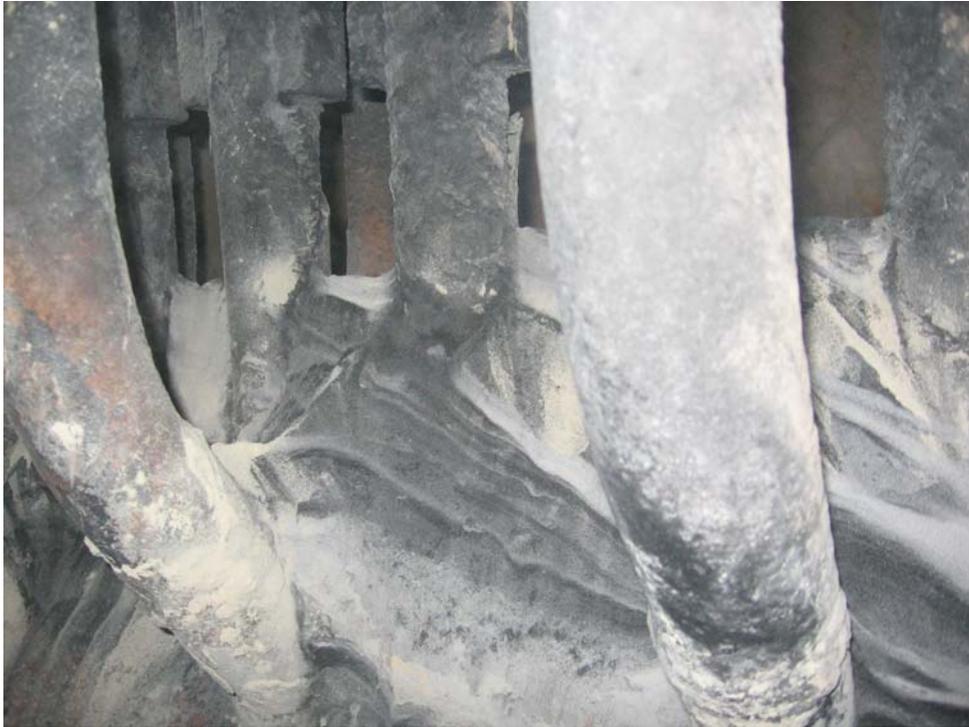
**44. West side dead air space. Ash on top of header**

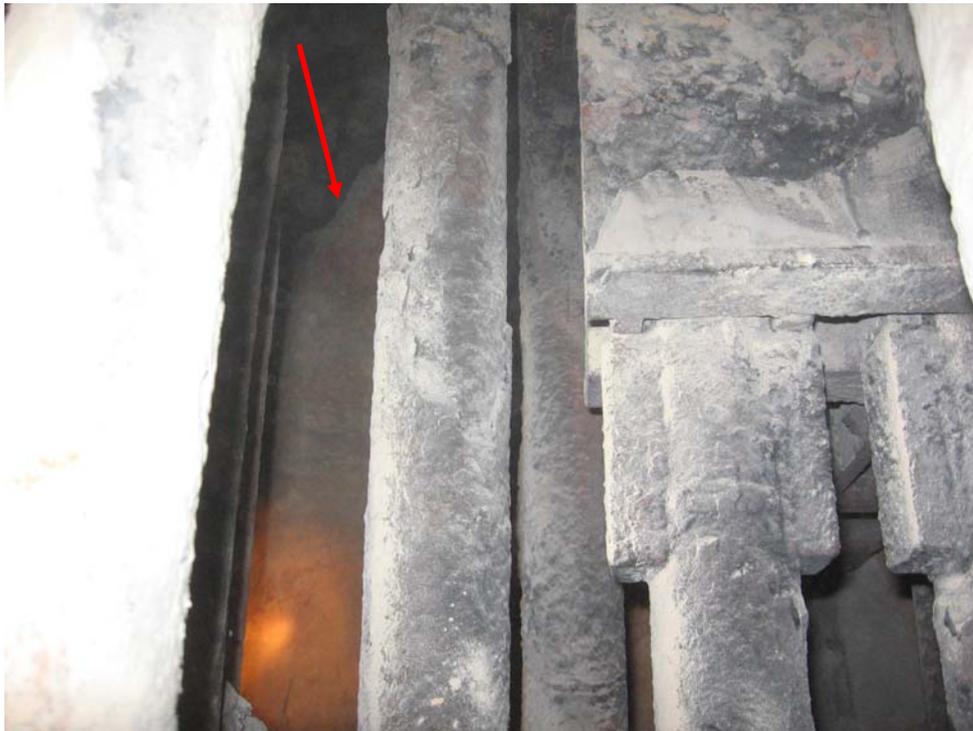
**45. West side dead air space before ash is completely removed  
Note level of ash behind tubes.**

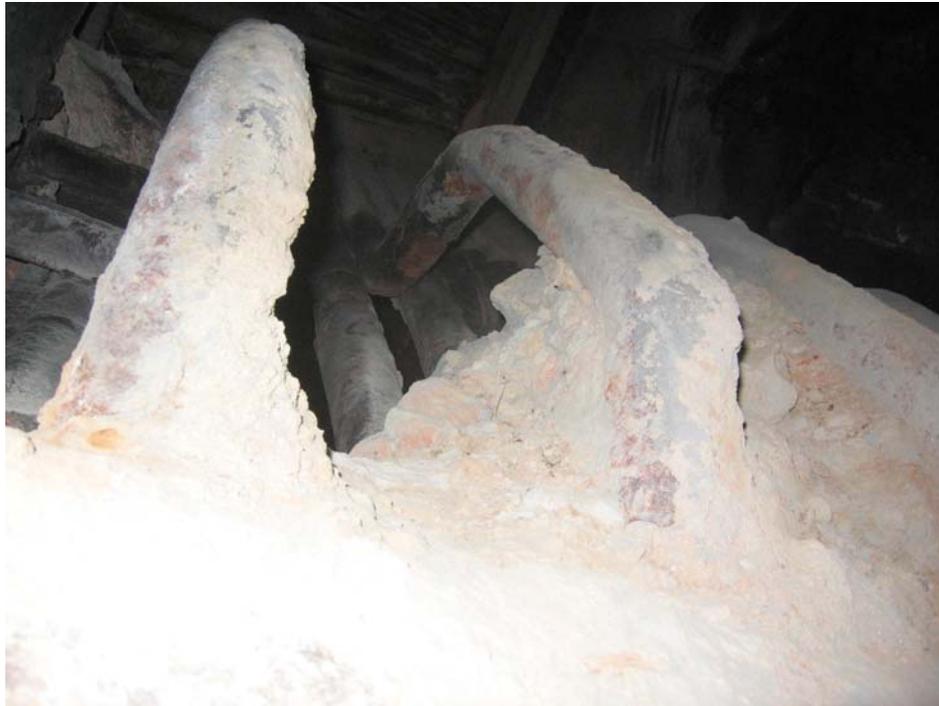
**48. West side dead air space before ash is completely removed  
Note impacted ash between tubes above header (buried)**

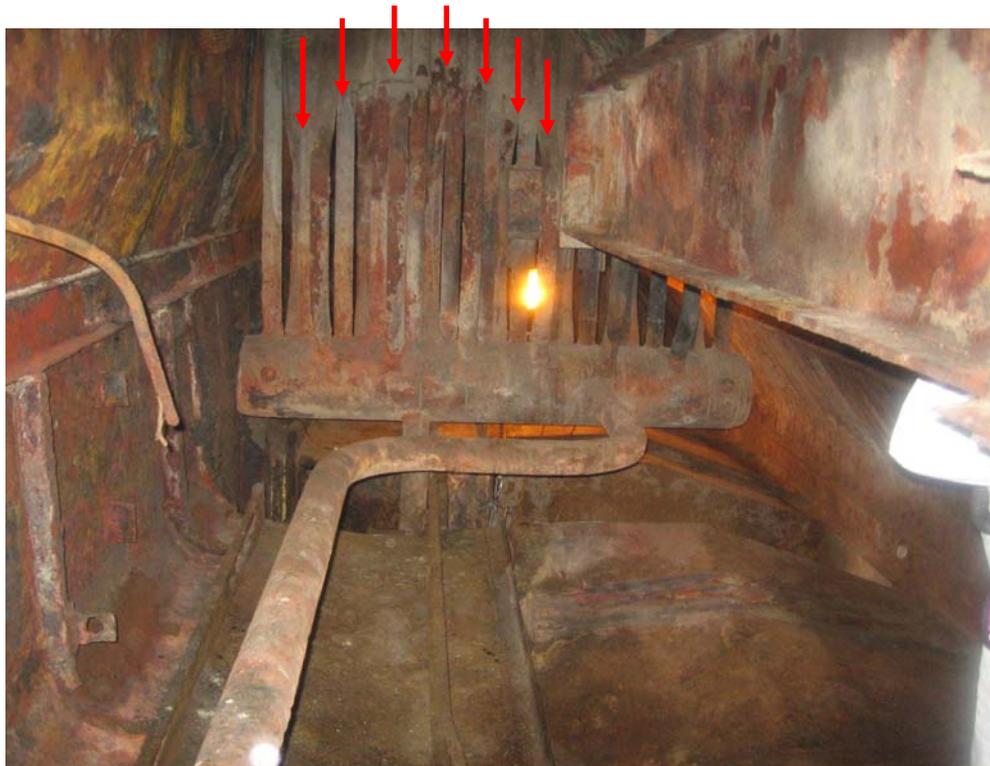
**49. West side dead air space after ash is removed.  
Prior level of ash is evident on division wall header**

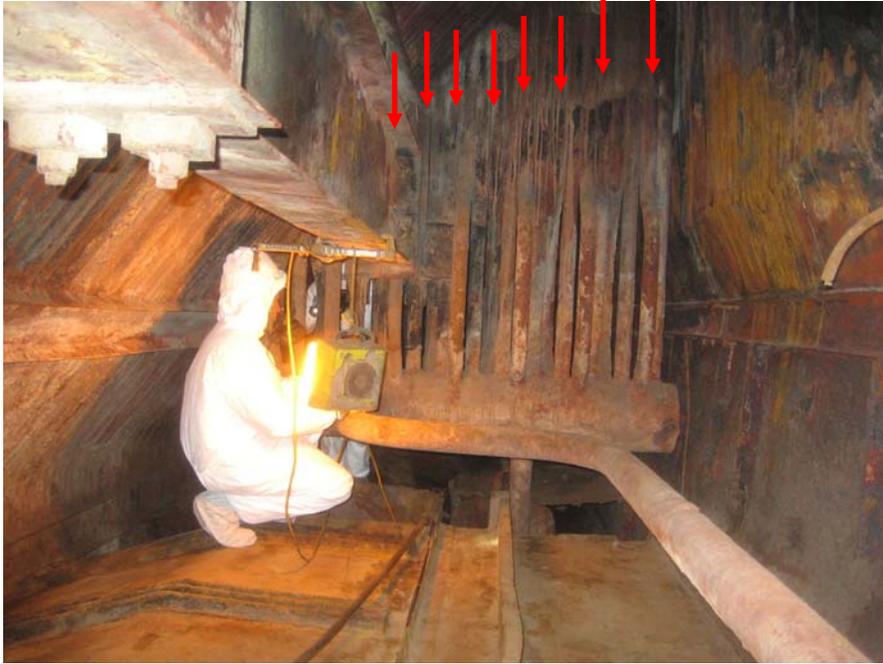
**50. West side dead air space after ash is removed. Prior level of ash is evident on division wall header**

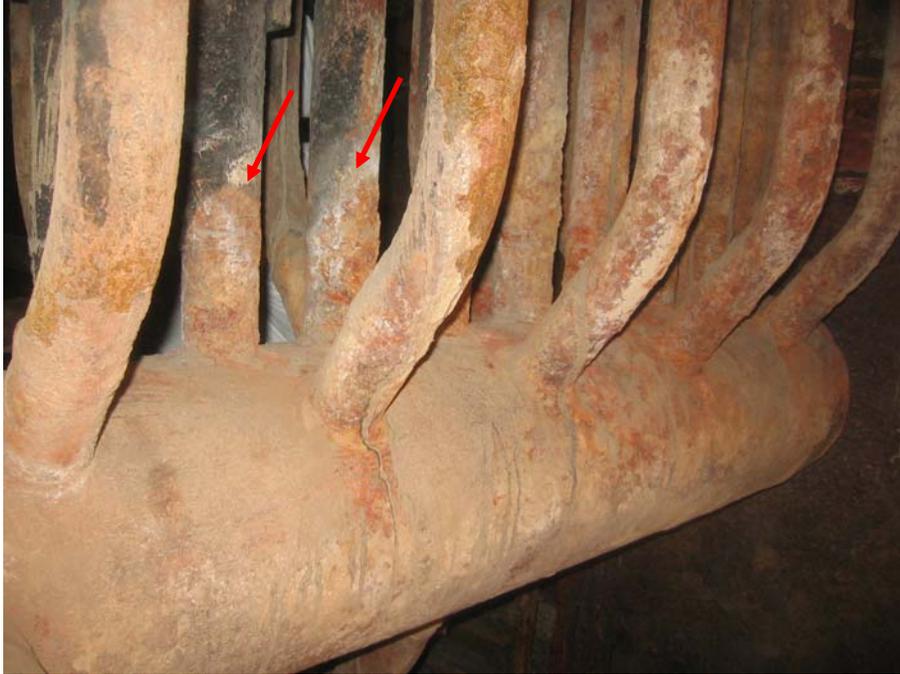
**52. West side dead air space after ash is initially vacuumed out.  
Difference in corrosion in tubes closest to header**

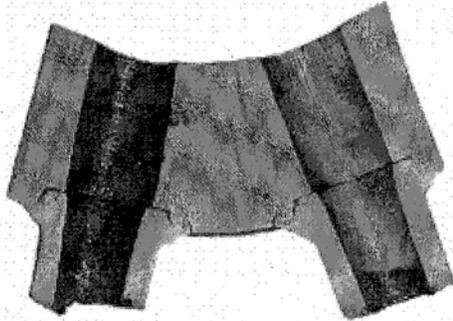
Fig. 5 Header bore hole cracking.
