**Commonwealth of Massachusetts**  
**Department of Public Safety**  
**INCIDENT REPORT**

*Dominion Energy New England - Salem Harbor Station*  
*Salem, MA*  
*Boiler #3 Failure - November 6, 2007*

**Graphic representation of failure area**

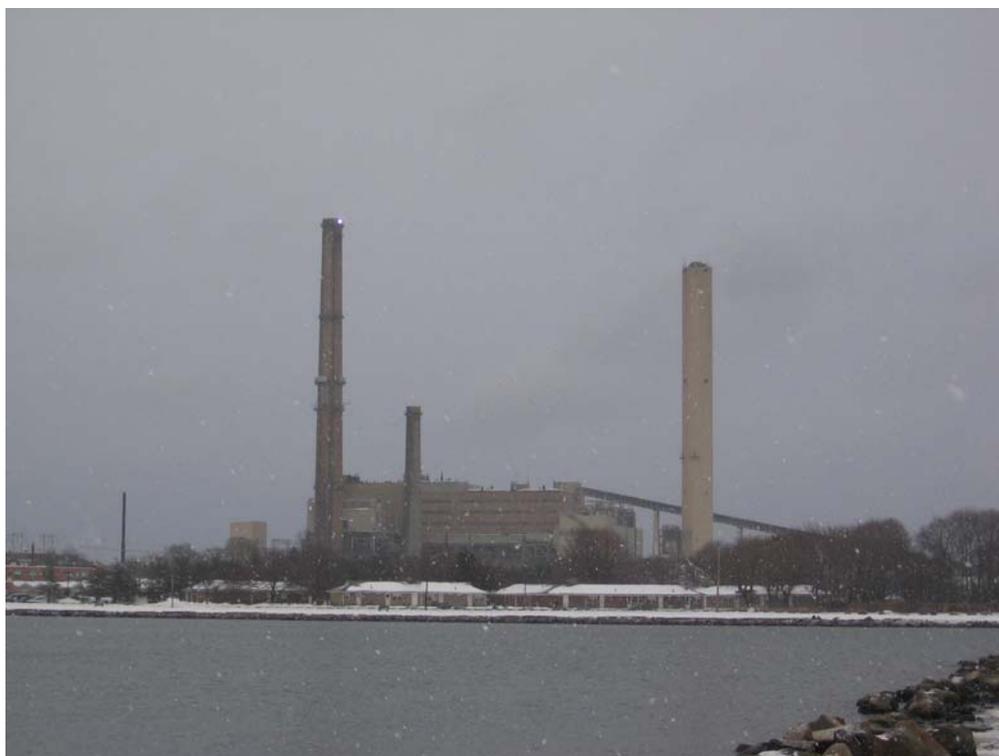
**1. Salem Harbor Generating Station  
Dominion Energy New England**

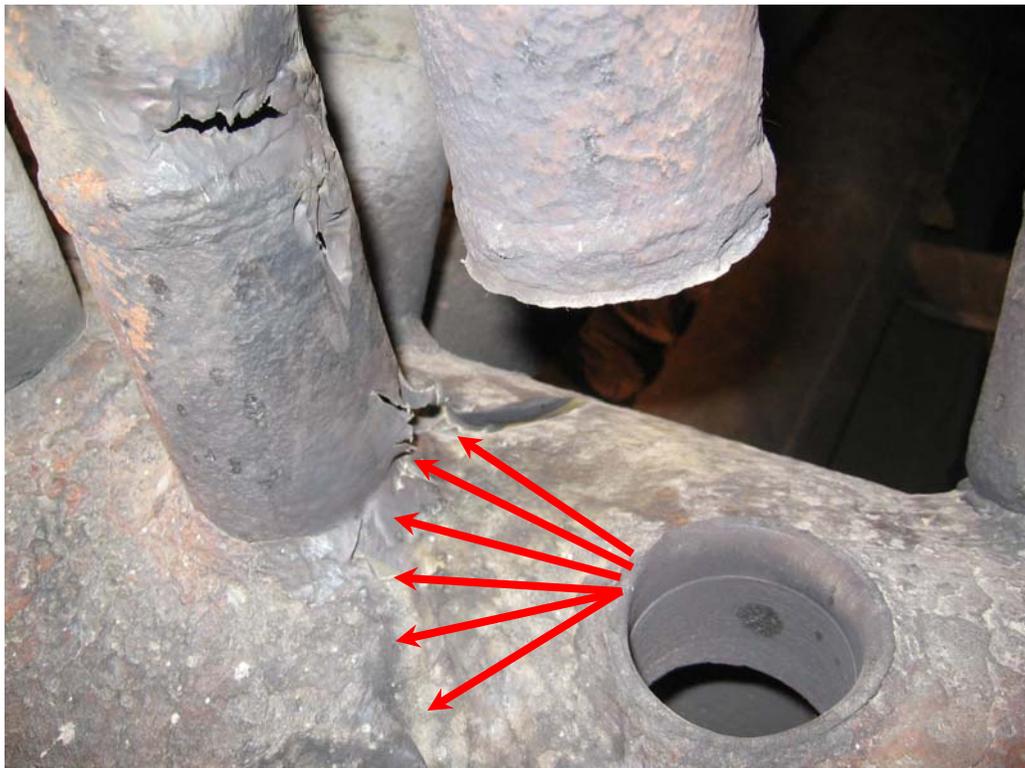
**14. Close-up of header at tube 9 and 11**

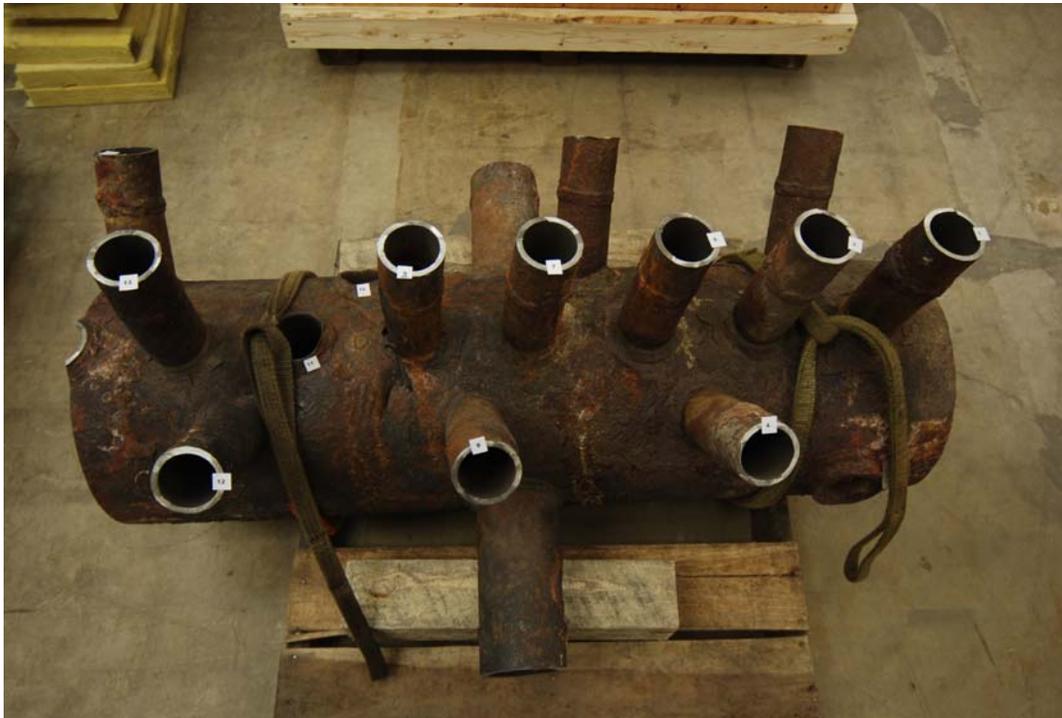
**16. Overview of header after being removed**

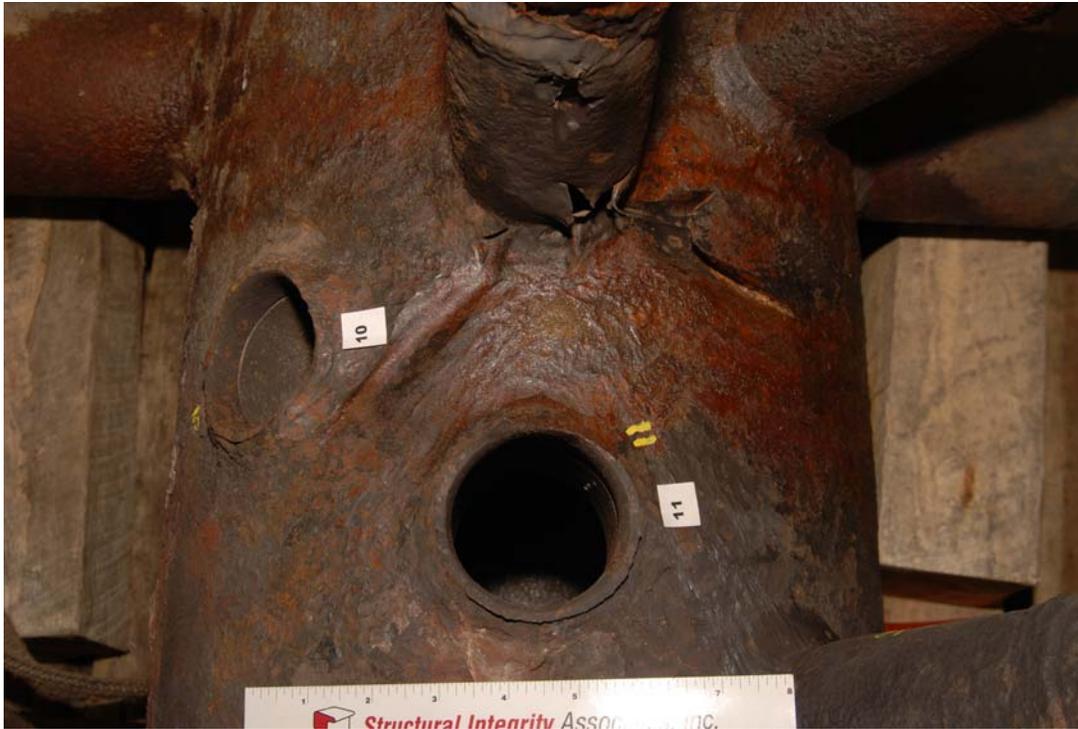
**17. Overview of header at failure area**

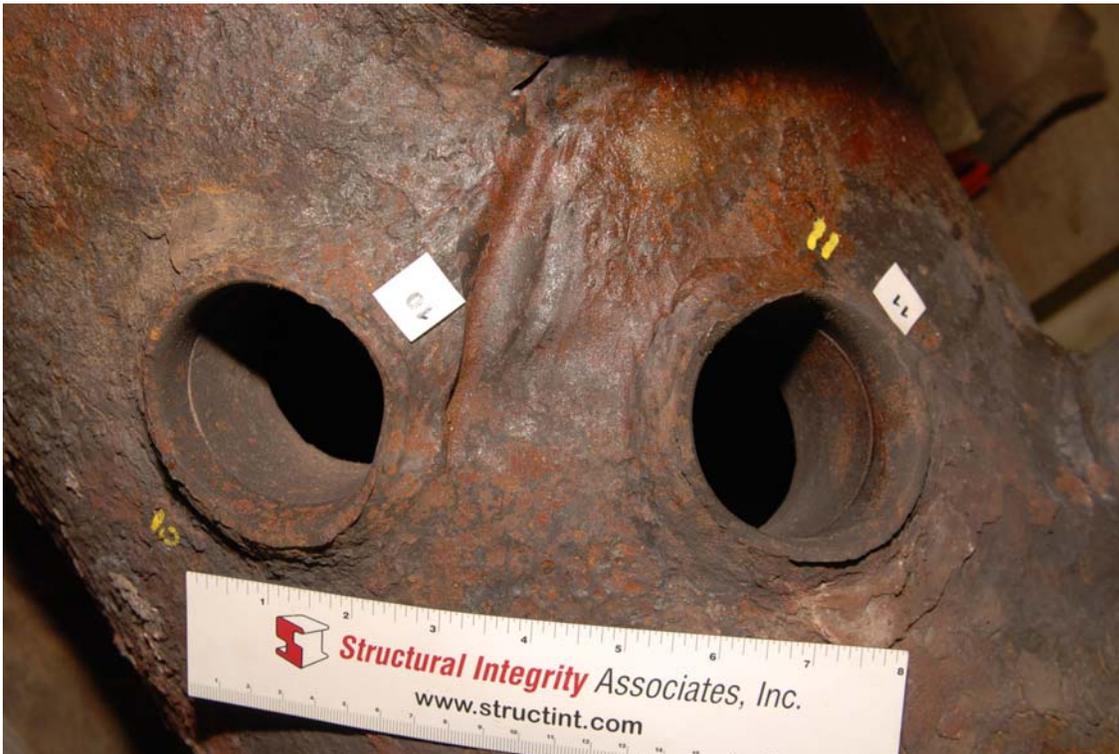
**18. Close-up of header at tube 10 and 11**

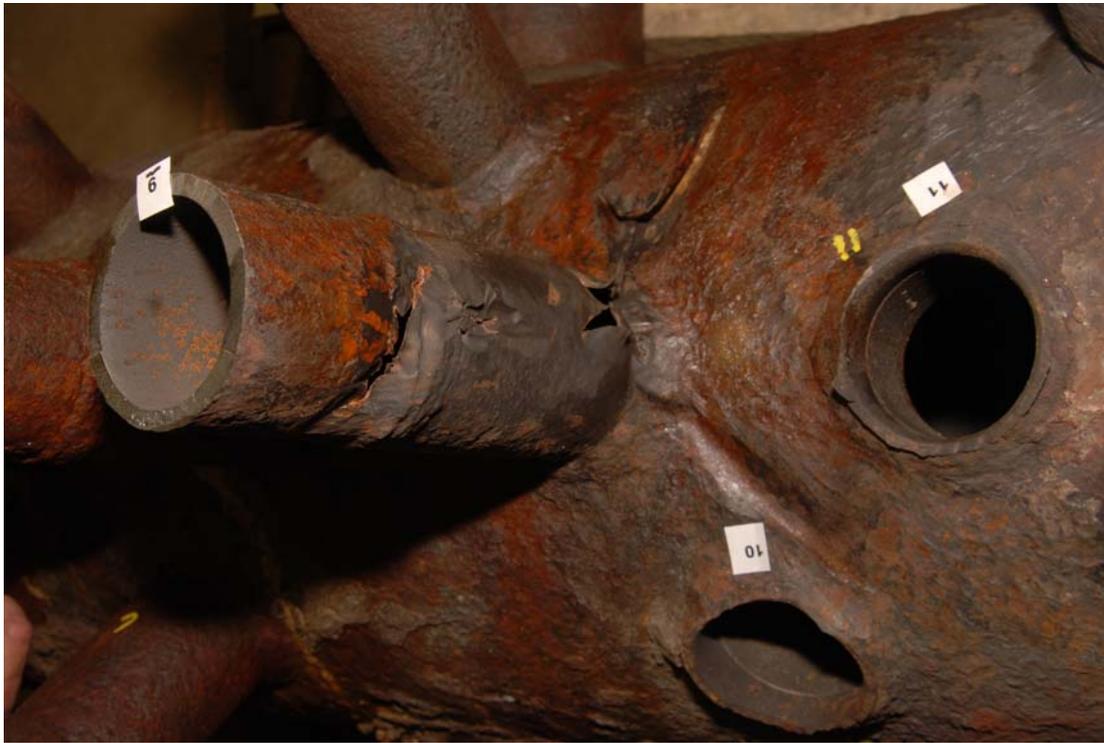
**19. Overview of header at point of failures**

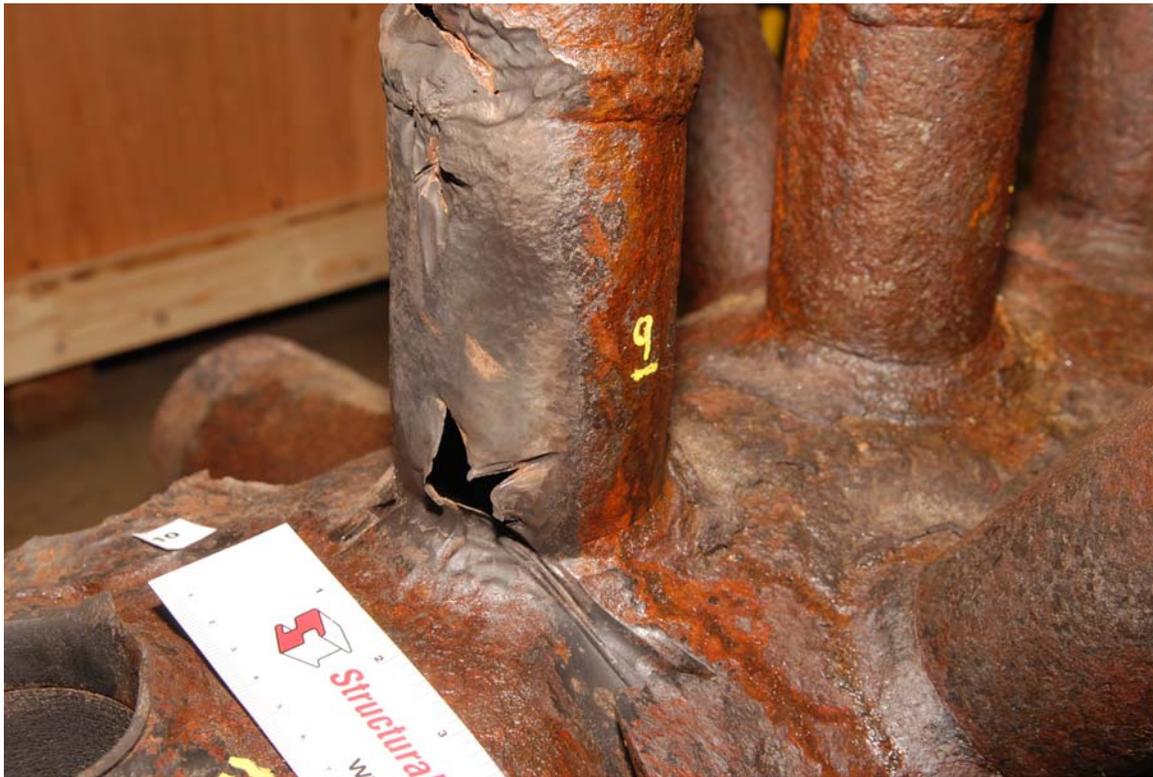
**20. Close-up of tube 9**

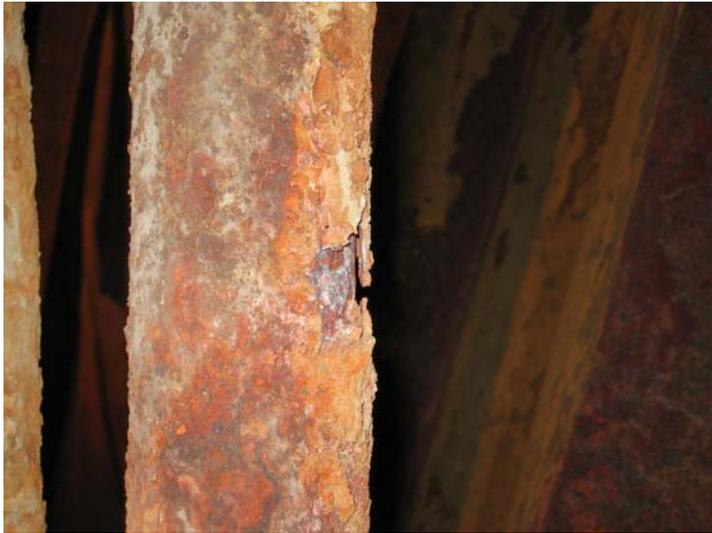
23

**Tube and Header Corrosion Photos (23 – 27)**

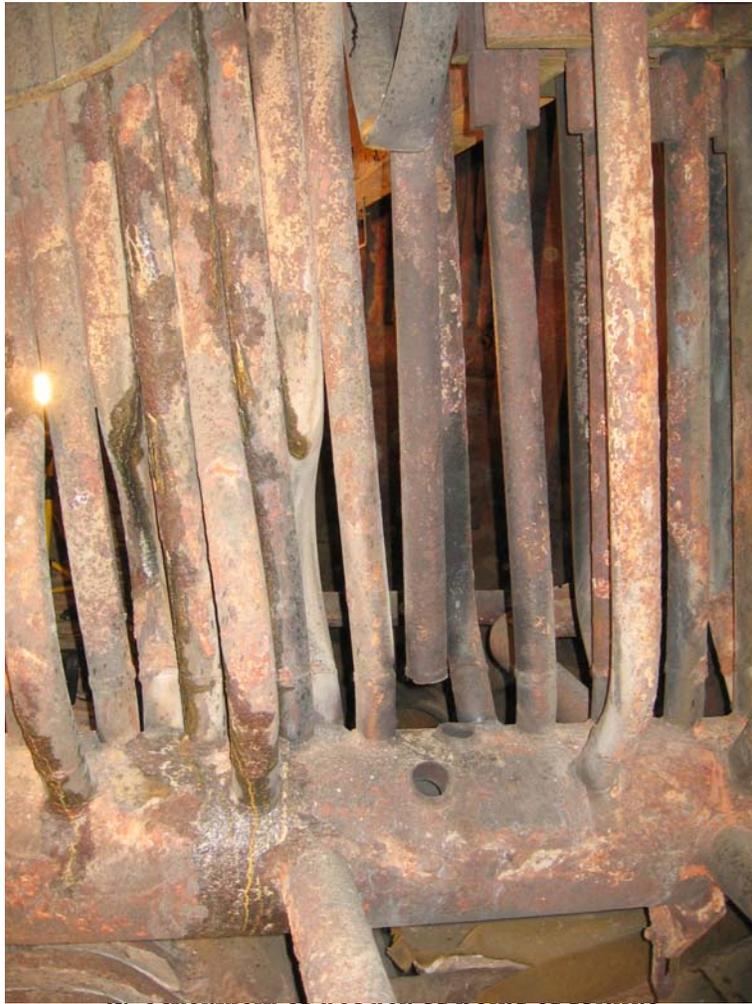
**28. Overview of header at point of failure**

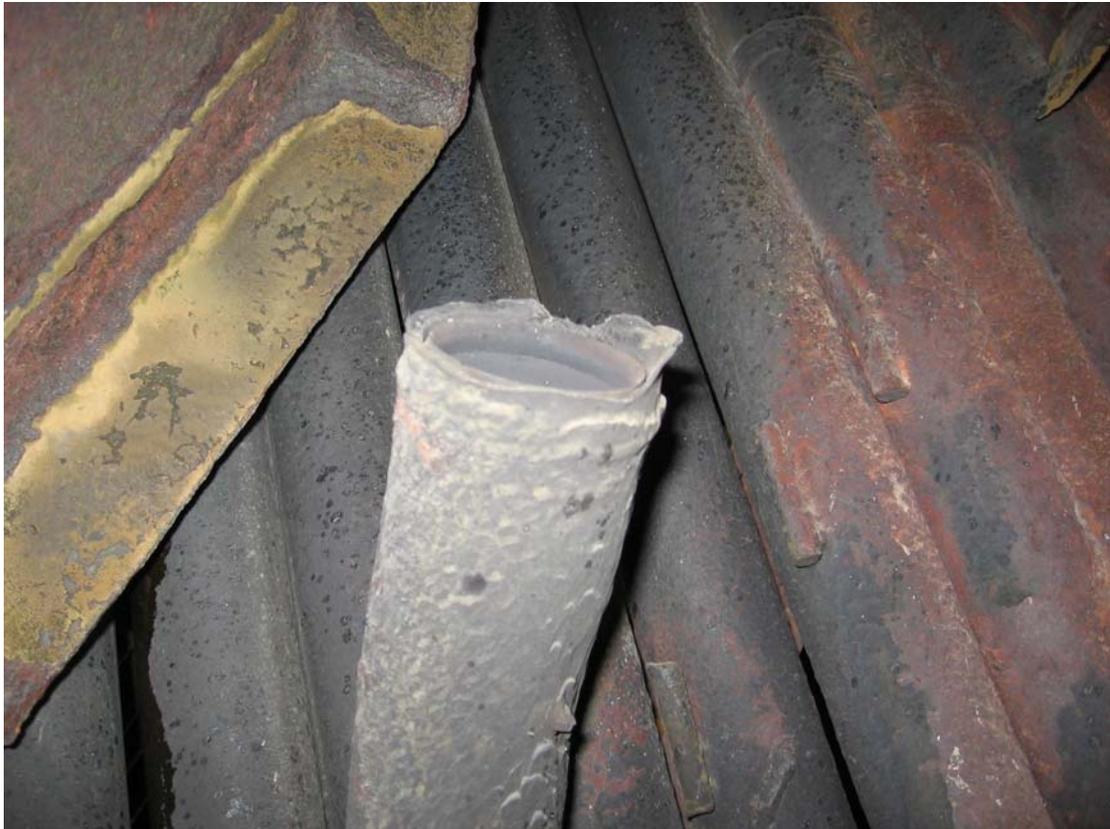
**32. Tube 10**

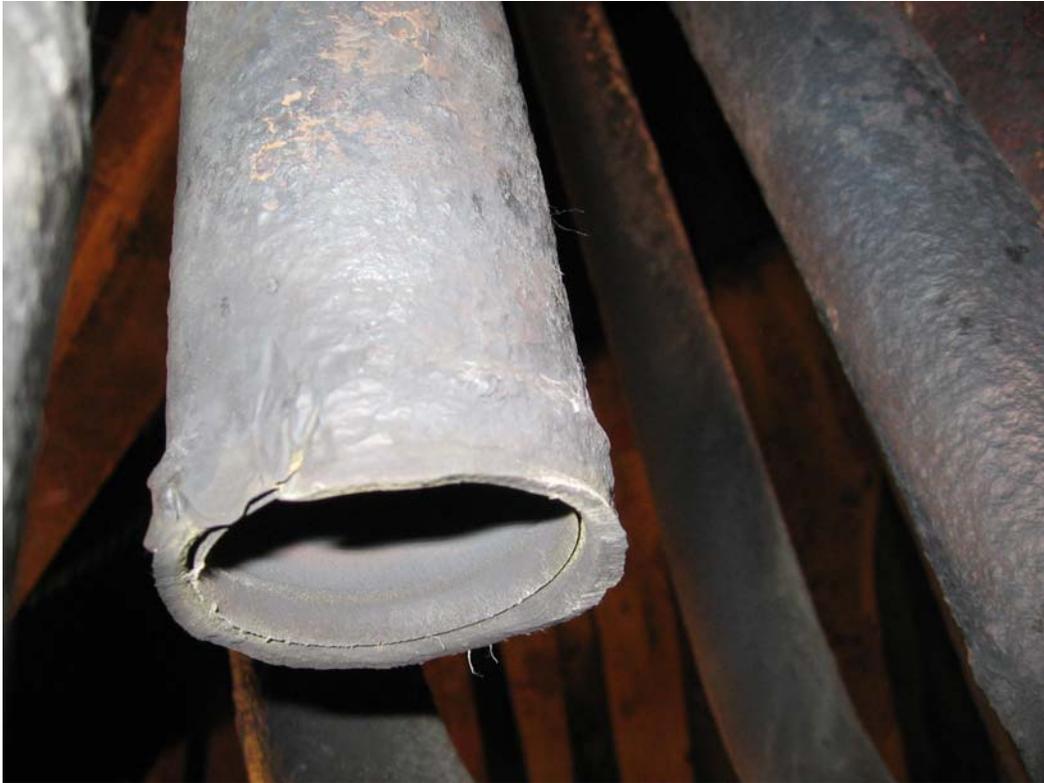
**34. Close-up of Tube 11**

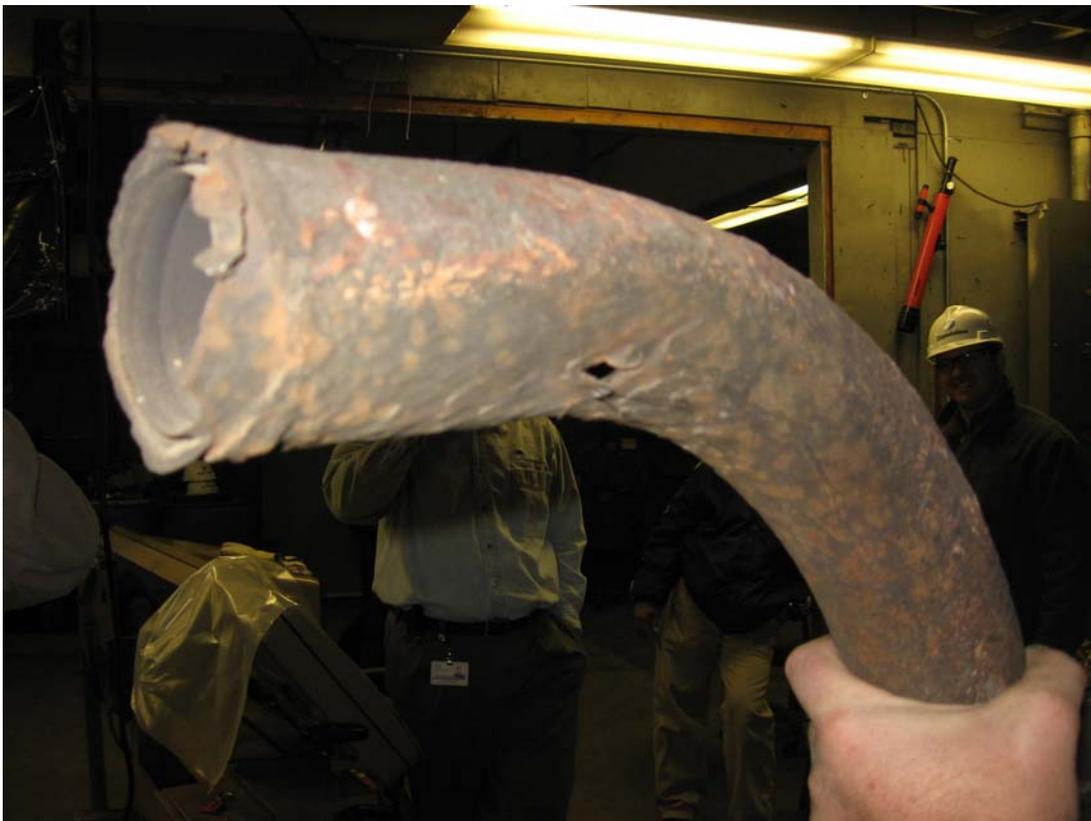
**35. Close-up of Tube 10**

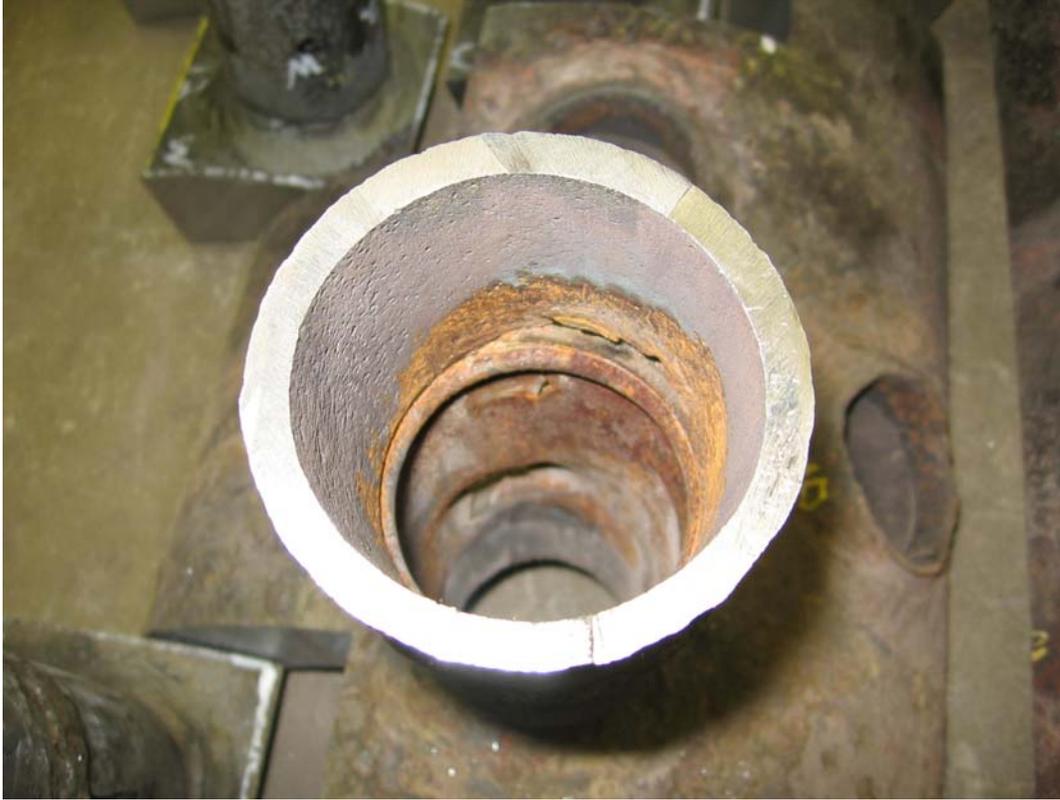
**36. Internal view of Tube 9**

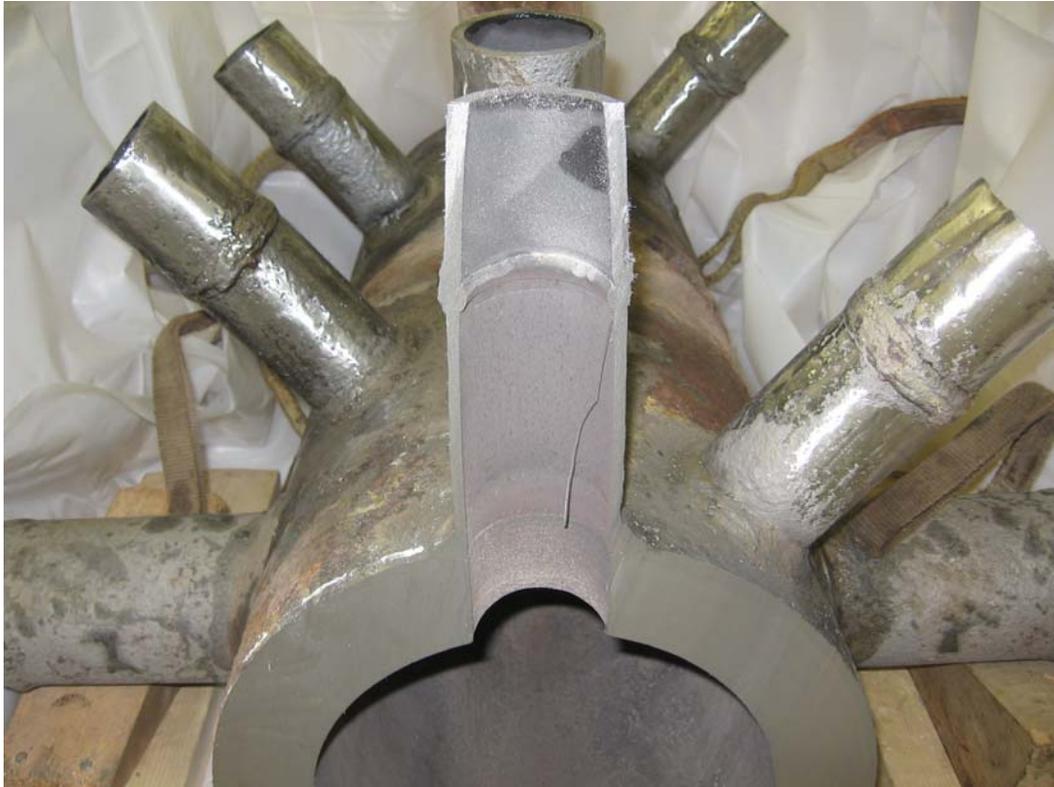
**37. View of header after cleaning**

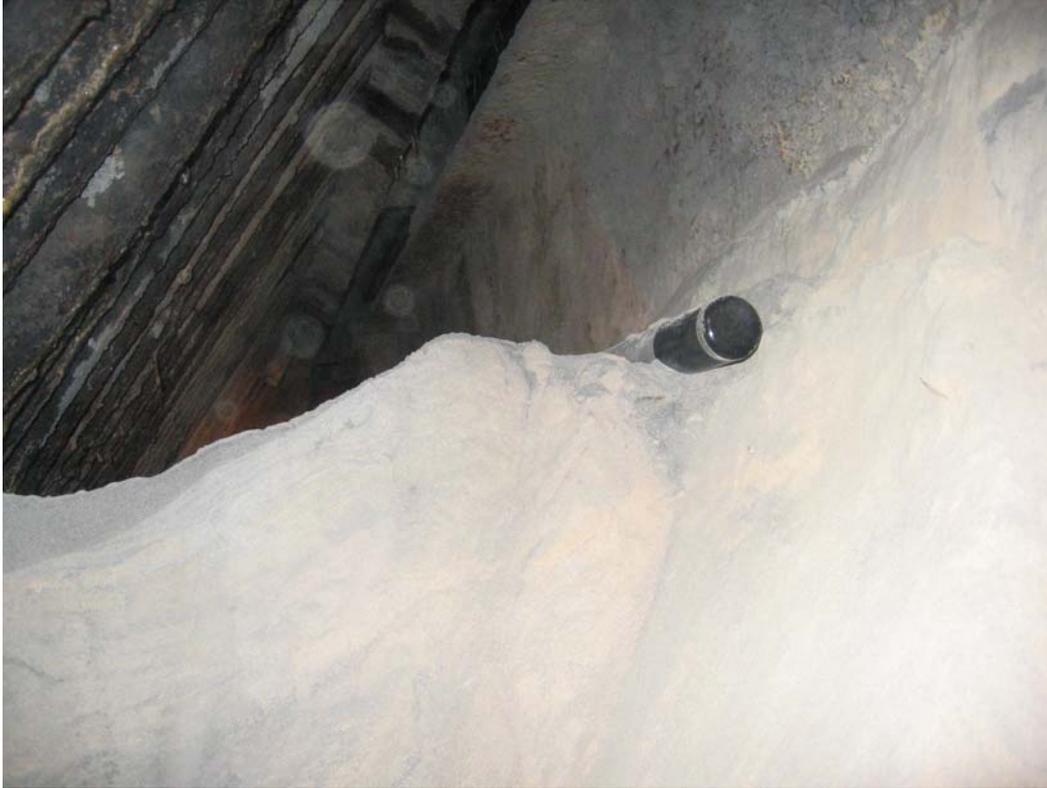
Further, when the west side dead air space was opened, these tubes did not have any obvious signs of urea contamination. It was determined that the ash acted as an insulator from any excessive urea slip (urea overspray). Combined with the large volume of ash that was in the dead air space, and the time it takes for the Urea to leak down to the dead air space if not restricted by ash, the presence of the Urea was discounted as a significant factor in the failure. Mooney and Kawa determined that the corrosion of the tubes and header within the dead air space was caused primarily from the interaction of the boiler metal with the ash and water (from boiler washing).

**42. West side dead air space before ash is completely removed**

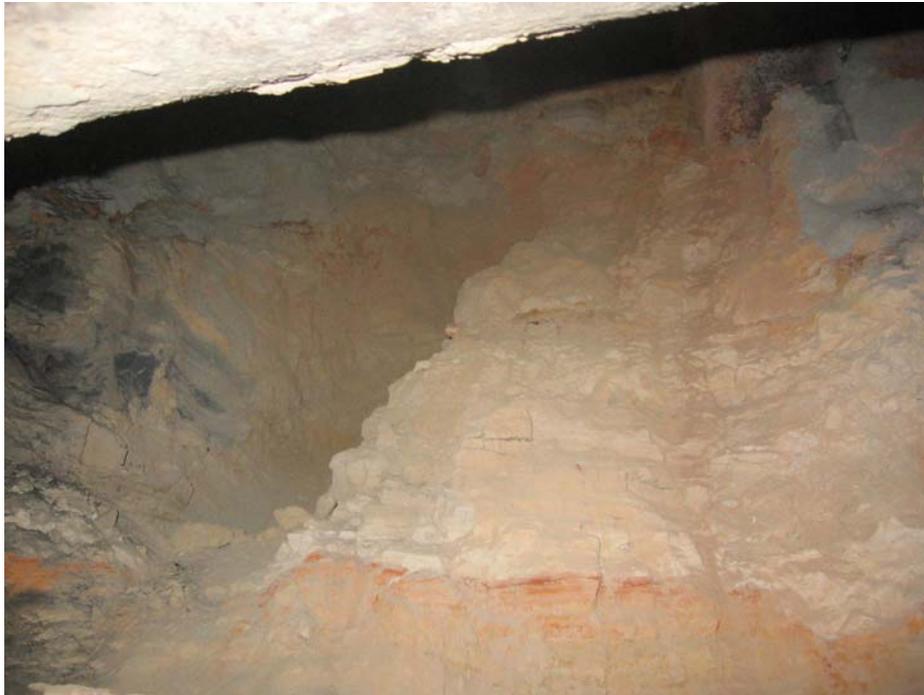
**46. West side dead air space before ash is completely removed**

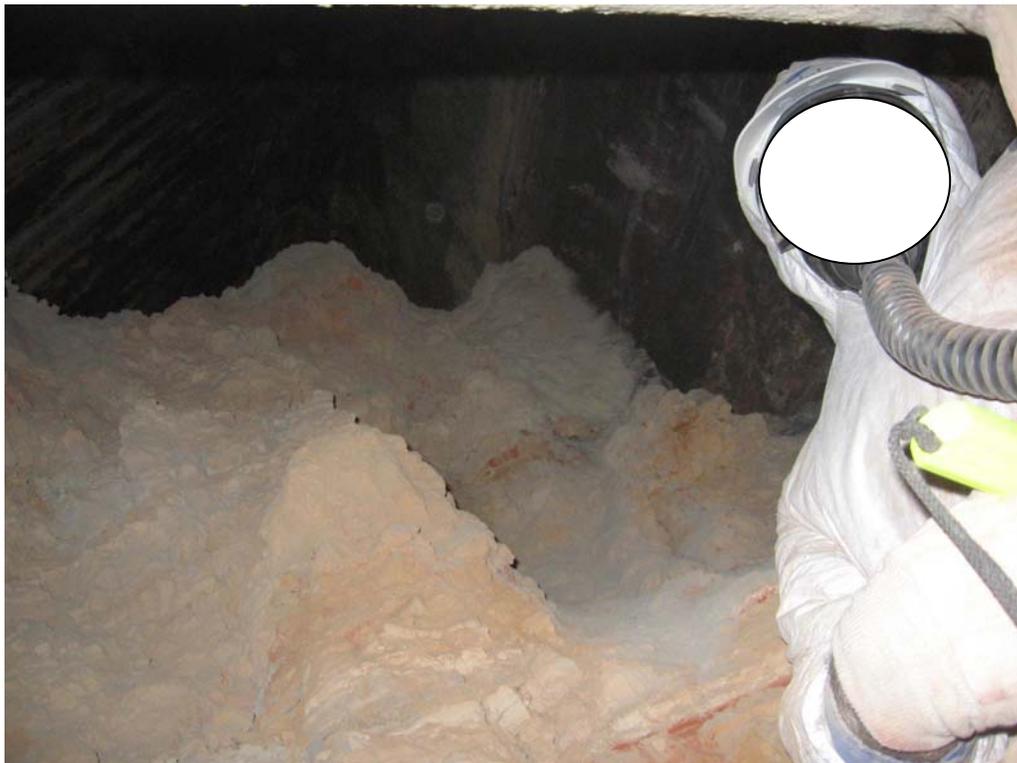
**47. West side dead air space before ash is completely removed**

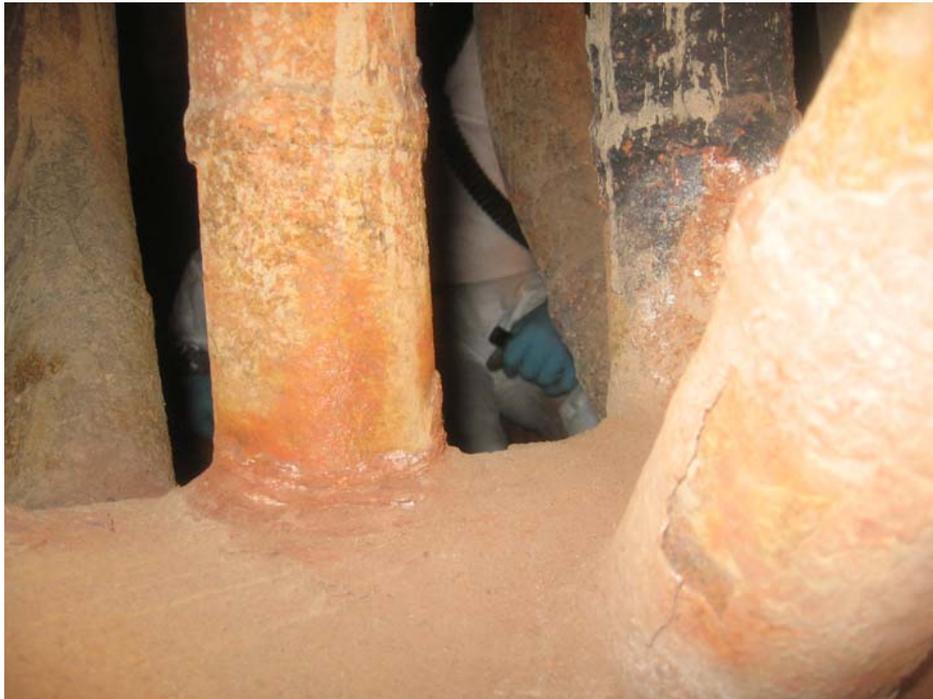
**51. West side dead air space header after ash is initially vacuumed out**
